DEPARTMENT OF TRANSPORTATION

Contract #: 04-0120F4Cty: SF/ALA Rte: 80 PM: 13.2/13.9File #: 1.28**WELDING INSPECTION REPORT****Resident Engineer:**Pursell, Gary**Address:** 333 Burma Road**City:** Oakland, CA 94607**Report No:** WIR-016078**Date Inspected:** 05-Aug-2010**Project Name:** SAS Superstructure**OSM Arrival Time:** 1000**Prime Contractor:** American Bridge/Fluor Enterprises, a JV**OSM Departure Time:** 1830**Contractor:** American Bridge/Fluor Enterprises, a JV**Location:** Job Site**CWI Name:** See Below**CWI Present:** Yes No**Inspected CWI report:** Yes No N/A**Rod Oven in Use:** Yes No N/A**Electrode to specification:** Yes No N/A**Weld Procedures Followed:** Yes No N/A**Qualified Welders:** Yes No N/A**Verified Joint Fit-up:** Yes No N/A**Approved Drawings:** Yes No N/A**Approved WPS:** Yes No N/A**Delayed / Cancelled:** Yes No N/A**Bridge No:** 34-0006**Component:** Orthotropic Box Girders**Summary of Items Observed:**

WELDING INSPECTION REPORT

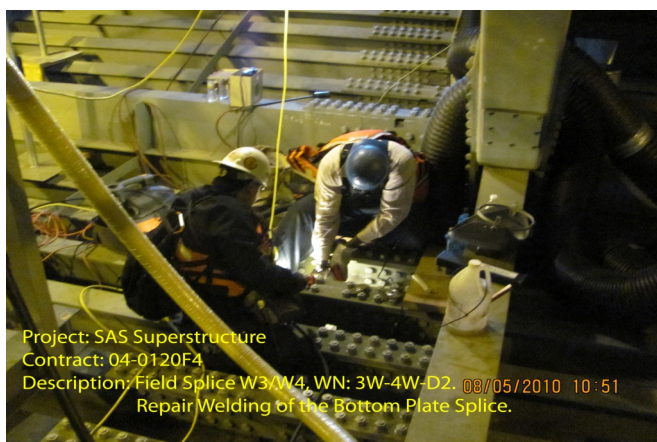
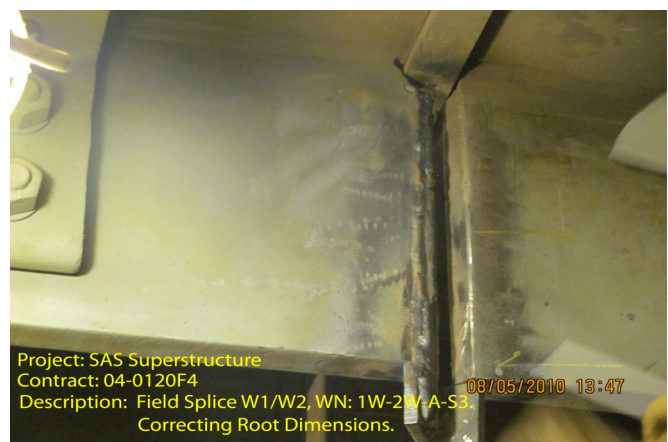
The digital photographs below illustrate the work observed during this scheduled shift.
